## **REQUEST FOR PROPOSALS (RFP)**

### **FLOW MONITORING, DATA ANALYSIS, AND REPORT FOR STORMWATER SEPARATION**

The WWIDA is issuing a Request for Proposals from professional engineering firms to complete an Inflow & Infiltration Reduction Analysis REPORT for a section of sewershed in the Washington County Sewer District No. 2 located in Hudson Falls, NY.

For additional information on the sewershed, please see the attached report entitled “Flow Monitoring Study for Washington County Wastewater Collection System – Village of Hudson Falls & Town of Kingsbury.”

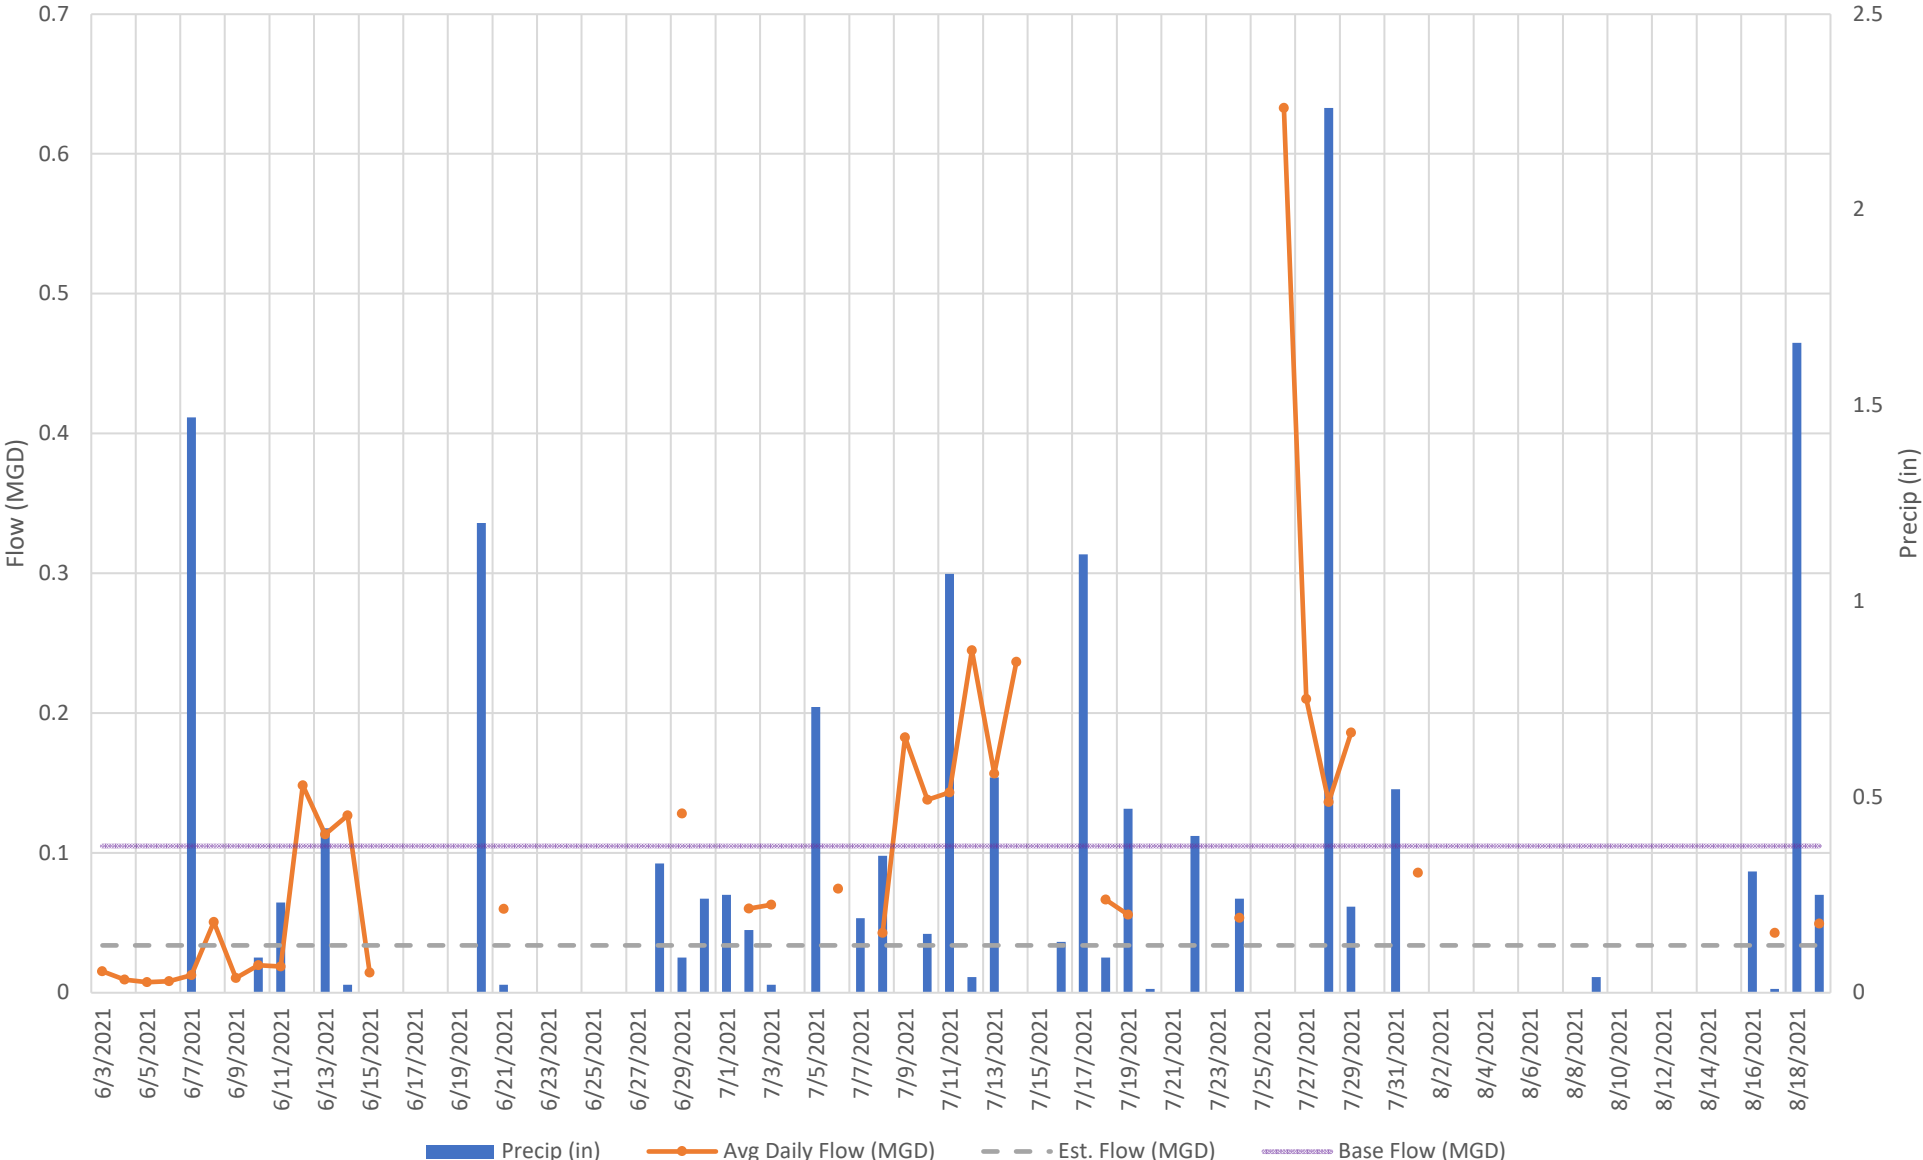
# Manhole 1A-5 Avg Daily Flows

■ Precip (in)    
 —●— Avg Daily Flow (MGD)    
 - - - Est. Flow (MGD)    
 ⋯ Base Flow (MGD)

its catchment area. As discussed later in this report, there is a potential that flows at this monitoring location were overestimated. A total of 22 surcharge events occurred at this monitoring location during the study period. A copy of the average daily and maximum daily flows recorded can be found in Appendix I.
